Access Study to all Pertinent Parts of
Dam Projects During High Reservoir
Conditions

Naugatuck River Basin Connecticut

February 1989

New England Division

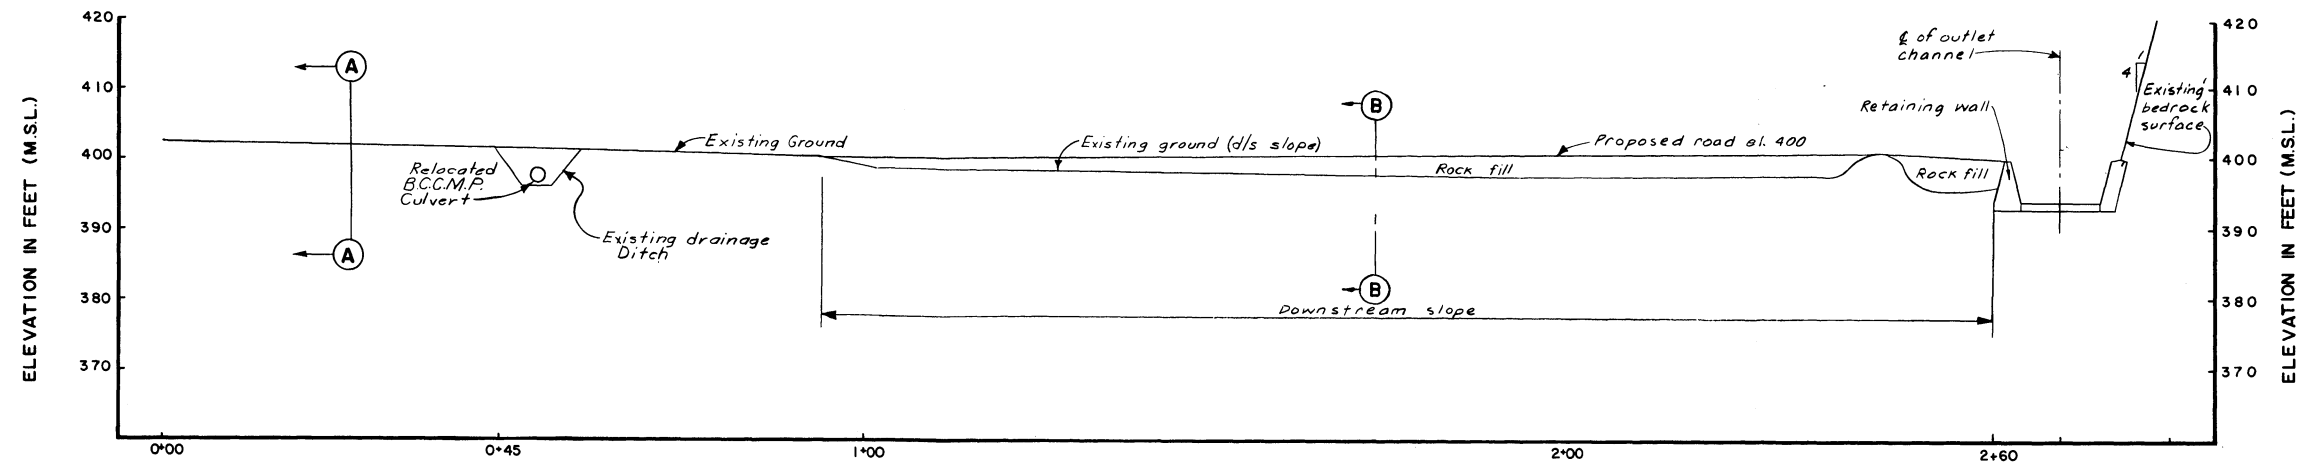
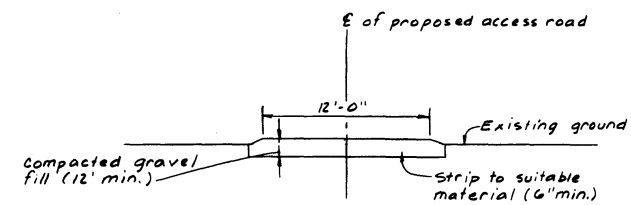
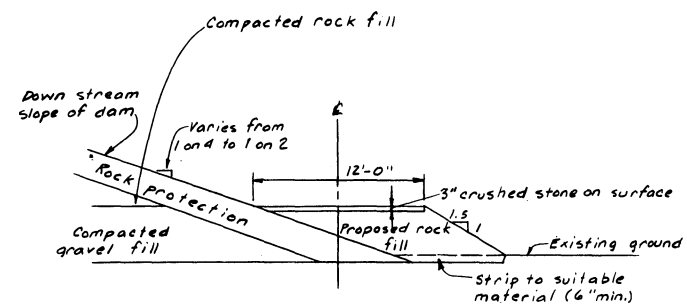
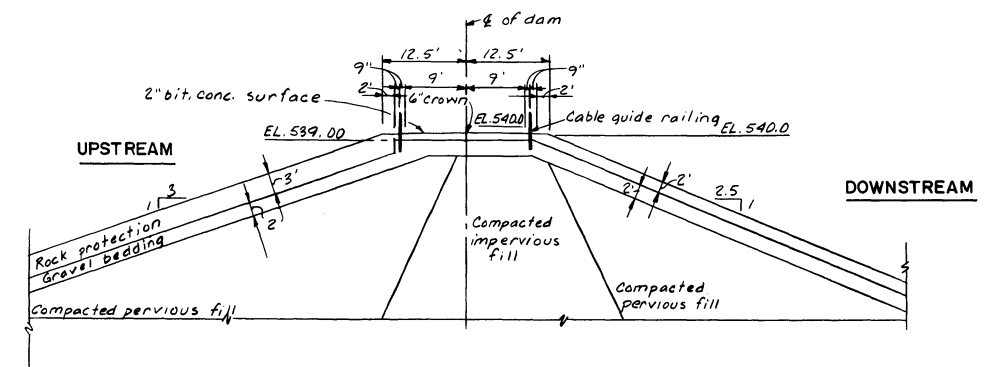
DEPARTMENT OF THE ARMY NEW ENGLAND DIVISION CORPS OF ENGINEERS WALTHAM, MASS.	
EMERGENCY ACCESS STUDY	
DES. BY:	NAUGATUCK RIVER BASIN
DR. BY:	BLACK ROCK DAM
CK. BY:	SECTIONS AND PROFILES
GEO TECH. ENG. BR.	SCALE: AS SHOWN
PLATE A-2	DATE: FEB. 1989

3. Adequacy of Access. Based on the design criteria, existing access to the downstream toe is inadequate. Although there is limited access to the toe throughout the valley section, from the outlet works to station 10+90, during heavy runoff conditions this area may be saturated making access to this reach of the toe (and the outlet works) impossible.

5.2 Black Rock Lake: A rock fill and gravel road meeting the design criteria should be constructed from the downstream side of the original Route 109 to the downstream toe of the dam and across the embankment slope to the outlet works, details of this recommended route are presented in Appendix A. The existing road from Black Rock State Park through the discharge channel to the outlet channel should be maintained through normal project maintenance and coordination with Black Rock State Park should be kept to insure that this route can be reached when required. The original Route 109 on the upstream side, which leads to a 15-foot wide berm extending to the base of the intake tower, should be maintained through normal project maintenance. As recommended above, a 15-foot wide strip should be kept clear of vegetation along the toes of the dam. Construction of the recommended route from the downstream end of the original Route 109 to the outlet works is given moderate priority.

4. Recommended Improvements. The downstream toe from station 0+00 to the outlet works is not accessible due to slopes of up to 55%, however, a 15-foot wide area should be maintained clear of vegetation for inspection purposes. Adequate access to the toe can be achieved by the construction of a gravel road from the original route 109, to the toe at about station 5+00 and across the downstream face of the dam to the outlet works. This access route should be constructed with a minimum of 12 inches of compacted gravel fill from the original route 109 to the downstream toe. The road should be constructed as a rock fill section with 3 inches of crushed stone on the surface from the downstream toe to the outlet works (see Plate No. A-2). Construction of this access route will be coordinated with recommendations for improved drainage and seepage monitoring at the downstream toe to include regrading and reseeding, reconstruction of drainage ditches, and clearing of vegetation throughout the area as outlined in Periodic Inspection Report No. 4, dated November 1988. Construction of this route is given moderate priority. Improvements for access to the downstream toe from station 10+90 to station 12+00 are not recommended due to numerous bedrock outcrops along this section of the toe, and abutment slopes of up to 25%.

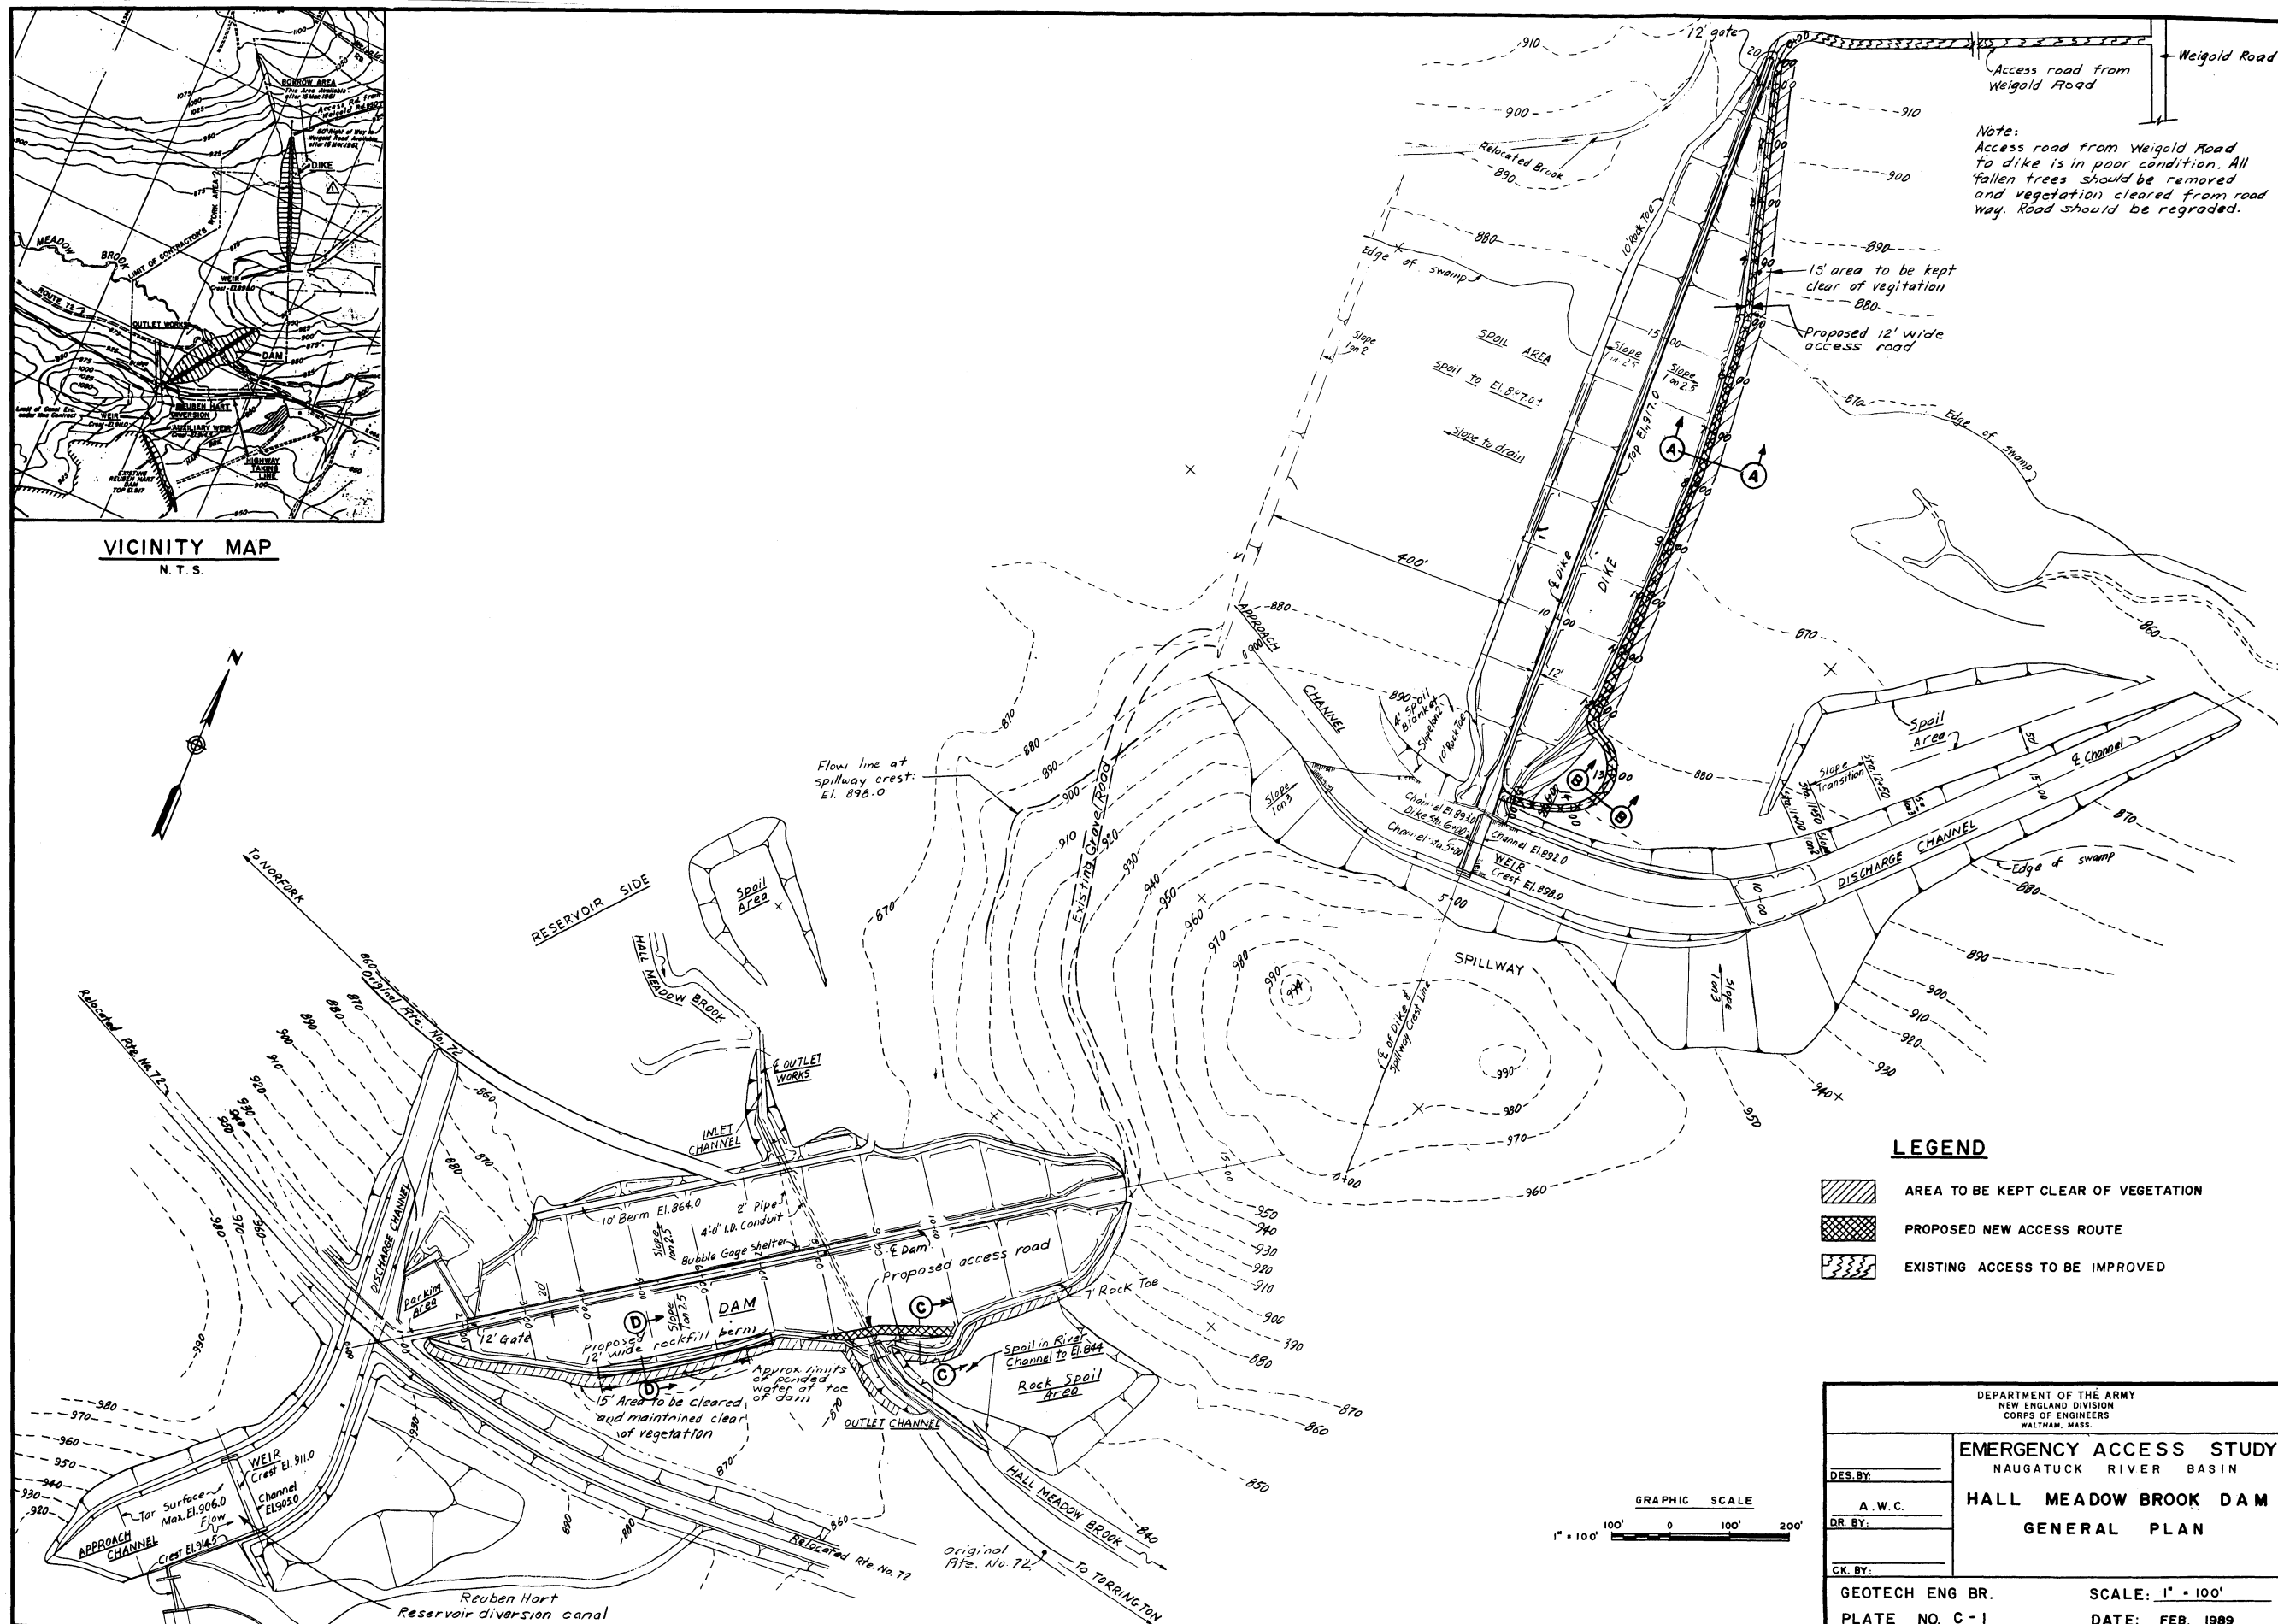
DEPARTMENT OF THE ARMY NEW ENGLAND DIVISION CORPS OF ENGINEERS WALTHAM, MASS.	
EMERGENCY ACCESS STUDY NAUGATUCK RIVER BASIN	
HALL MEADOW BROOK DAM GENERAL PLAN	
DES. BY:	A.W.C.
DR. BY:	
CK. BY:	
GEOTECH ENG. BR.	SCALE: 1" = 100'
PLATE NO. C-1	DATE: FEB. 1989

14. Existing Access. Access to the crest of the dike is provided by a gravel crest service road in fair condition. The crest service road is reached via a haul road in poor condition which extends from Weigold Road to the crest of the dike (see Plate No. C-1). Access to the downstream toe is limited to the lowering of equipment down the face of the dike. The downstream toe has a 7-foot wide rock berm which is not wide enough to allow access by construction equipment. Portions of the downstream toe are inundated by water from an adjacent swamp especially during high runoff periods, and vegetation including trees to 18-inches are growing along the rock toe limiting access and making inspection difficult.

15. Adequacy of Access. Access to the crest of the dike is considered adequate at this time provided the haul road from Weigold Road is improved. Existing access to the downstream toe is inadequate.

Note:
Access road from Weigold Road
to dike is in poor condition. All
fallen trees should be removed
and vegetation cleared from road
way. Road should be regraded.

16. Recommended Improvements. The existing haul road from Weigold Road to the crest of the dike is in poor condition and should be improved by regrading, addition of minor quantities of gravel fill where needed, removal of obstructions including down trees and other improvements to insure that the design vehicles can reach the dike crest service road. No improvements to the crest service road are recommended at this time. The 7-foot wide rock berm at the downstream toe should be extended to 12 feet and all vegetation within 15 feet of the toe of the berm should be cleared to facilitate inspection (see Plate No. C-2). At the spillway end of the dike, the access route along the downstream toe should turn away from the embankment and follow the left side of the spillway discharge channel to the crest of the dike as shown on Plate No. C-1. This alignment will also improve access to the left side of the spillway discharge channel which is presently inaccessible during spillway discharge. Improvements to the wood road from Weigold Road to the crest of the dike is given low priority. Construction of the downstream toe access route is given low priority.

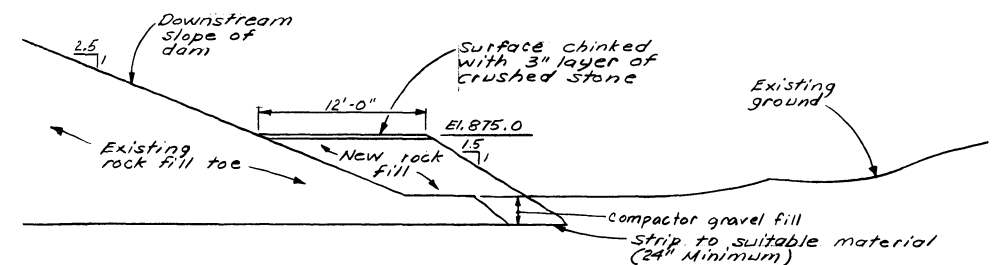
PROPOSED ROCK FILL BERM AT TOE OF DAM (STA. 4+00 TO 6+90)

3. Adequacy of Access. Access to the toe from about station 6+50 to the outlet works at about station 8+65 is adequate at this time. Access to the toe between the outlet works and the left abutment and from the right abutment to about station 6+50 is inadequate.

4. Recommended Improvements. A rock fill berm should be constructed along the downstream toe at elevation 875.0 MSL from station 6+90 to station 4+00 to allow access to the downstream toe at the right abutment from the original Route 72. A 12 foot wide rock fill access road with a crushed stone surface, approximately 200 feet in length, should be constructed to allow access to the downstream toe and spoil area between the left abutment and the outlet works from the downstream toe at the right side of the outlet works. The road should be constructed from the downstream toe at about station 8+00, across the downstream face of the dam above the outlet works to the downstream toe at about station 10+00. All vegetation along the downstream toe should be cleared to 15 feet from the toe, particularly along the downstream left abutment. Construction of the rock fill berm at the downstream toe of the dam is given low priority.

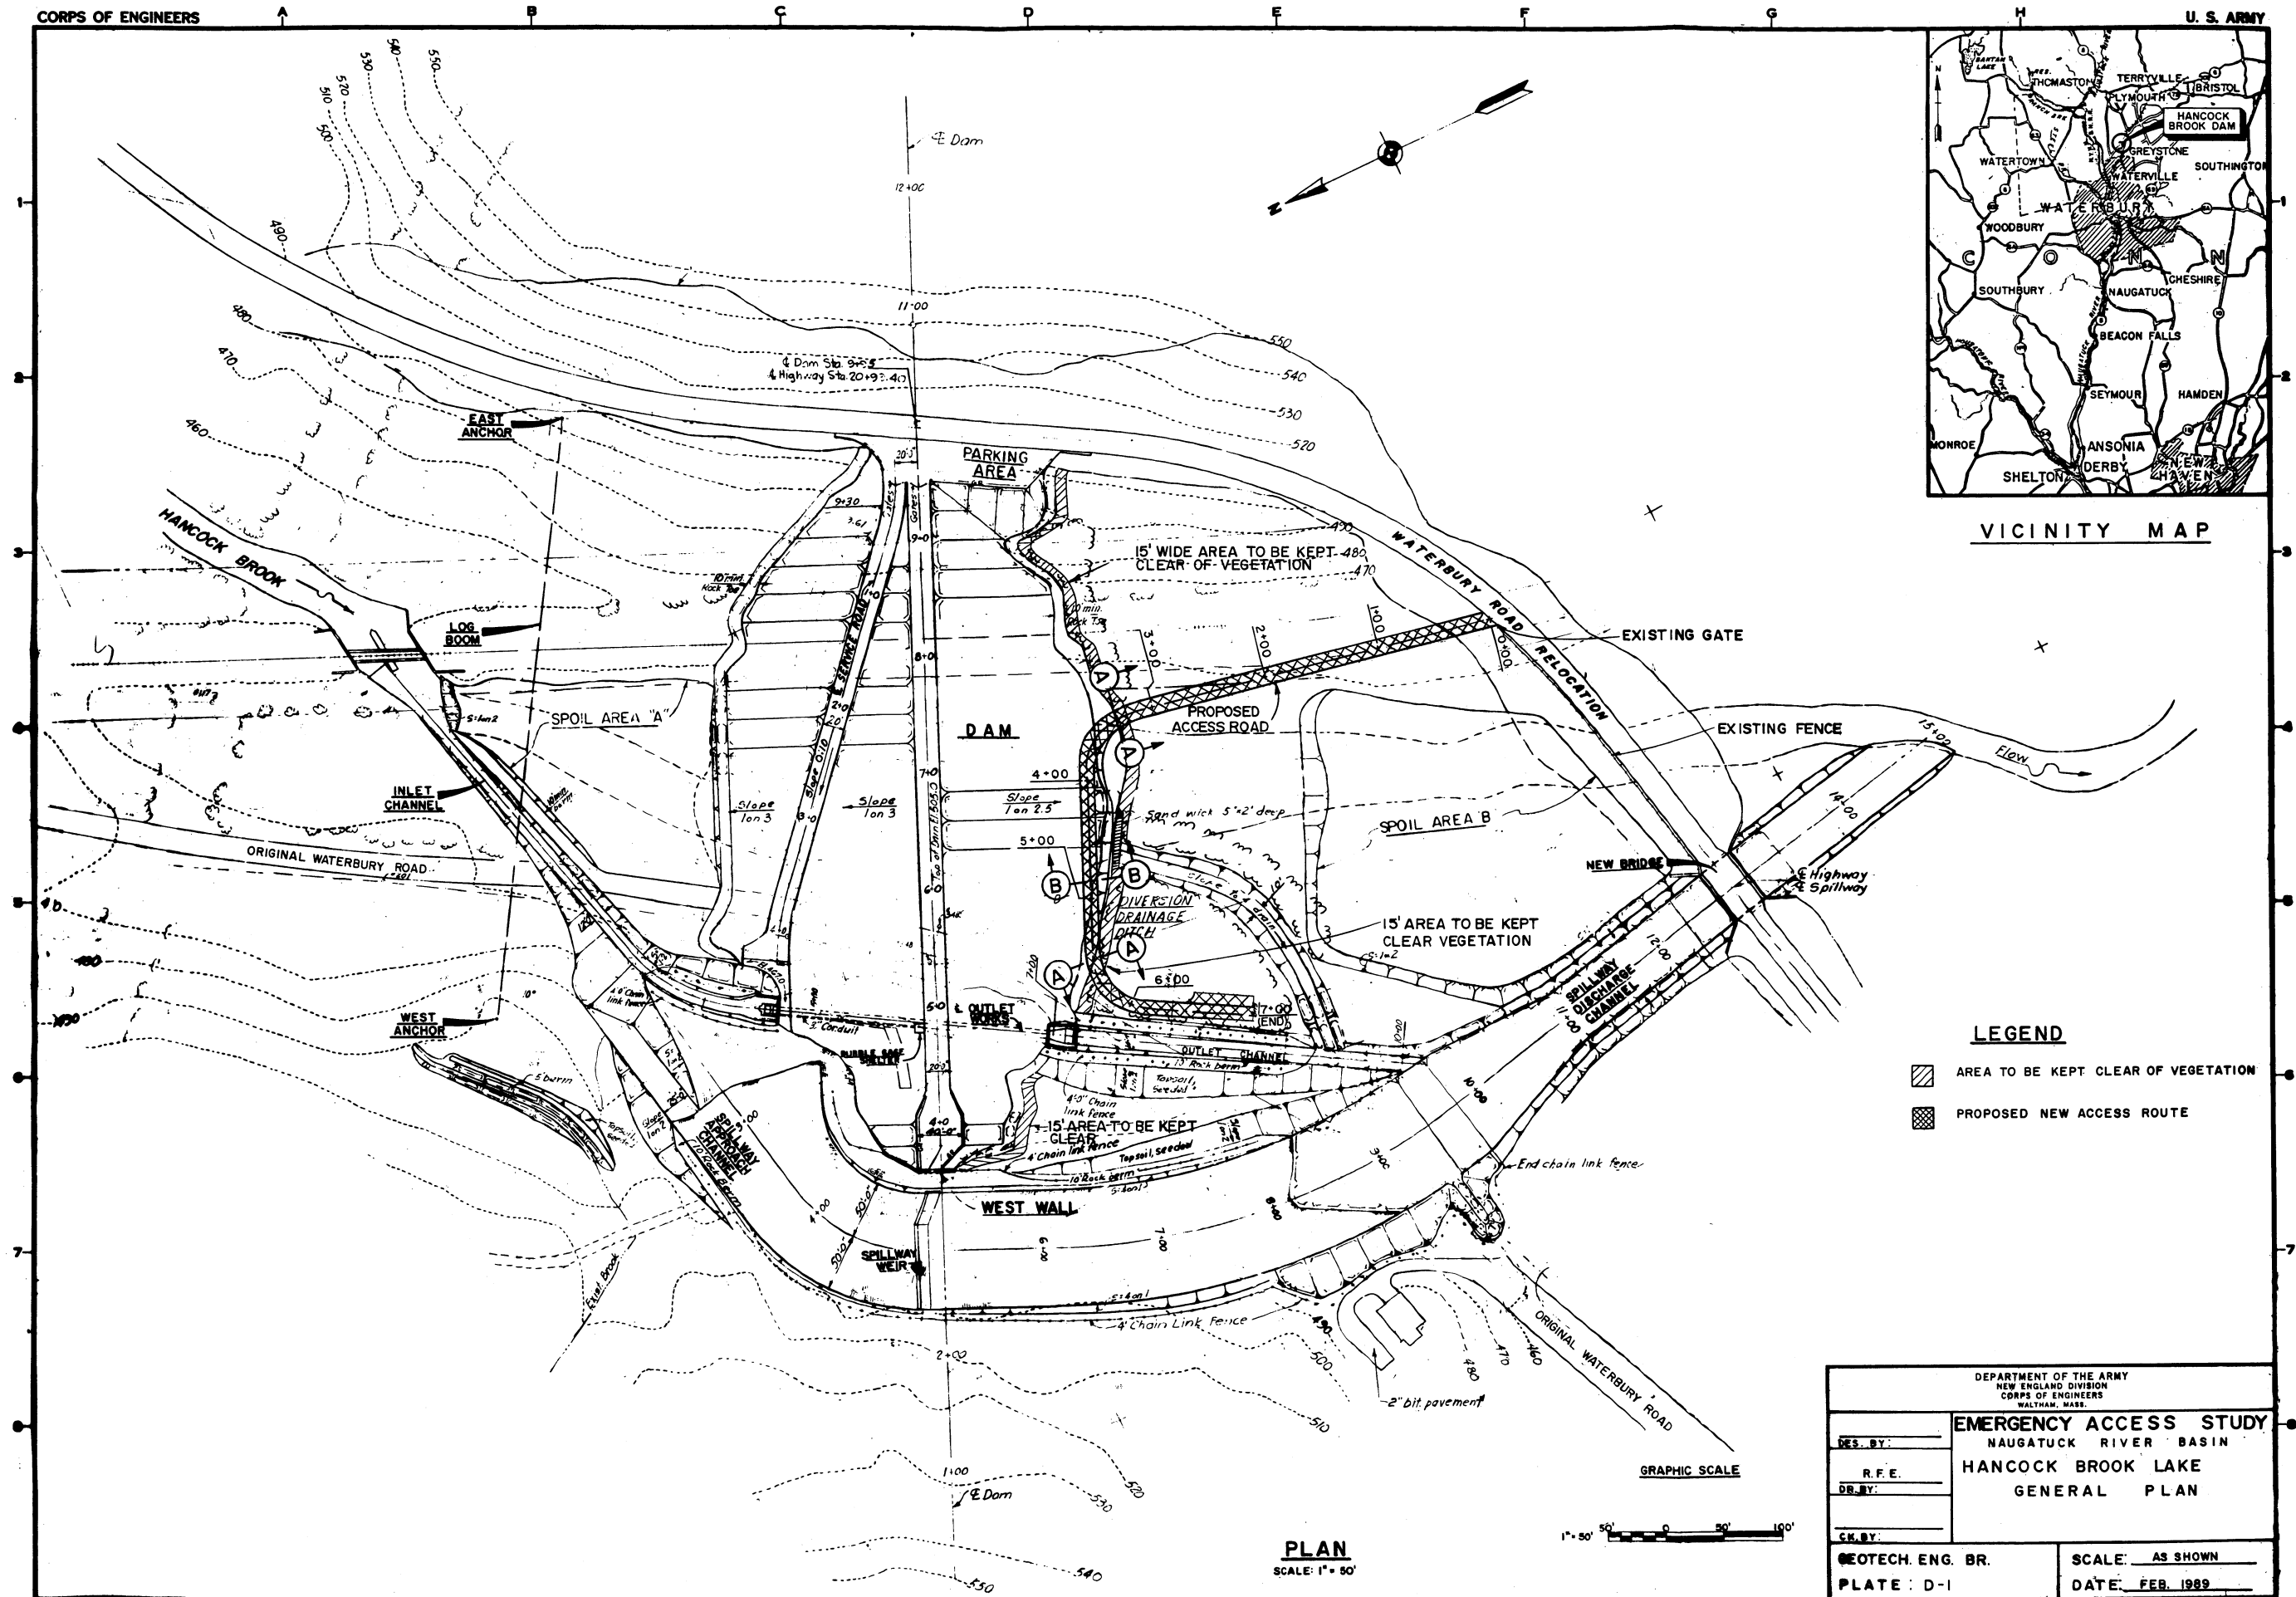
3. Adequacy of Access. Access to the downstream toe is considered to be inadequate between the outlet works and station 6+60 and from station 7+60 to the left abutment.

9. Adequacy of Access. Access to the inlet channel and intake structure is considered adequate. Access to the outlet works is considered inadequate due to the drainage ditch which lies between the outlet channel and Waterbury Road.

4. Recommended Improvements. For adequate access to the downstream toe a gravel road should be constructed from an existing gate at Waterbury Road to the toe at station 7+40. The access route should continue along the downstream face of the embankment above the ponded water at the toe as a rock fill section with a crushed stone surface. The access road should turn away from the dam at about dam station 5+15 and continue along the left side of the outlet channel as shown on Plate No. D-1. Construction of this route is given low priority. A 15 foot wide strip should be kept clear along the toe at the downstream left abutment and between the spillway and the outlet works for emergency equipment and inspection purposes.

10. Recommended Improvements. Construction of the recommended downstream toe access route along the left side of the outlet channel will provide adequate access to the outlet channel and the outlet structure (see Plate No. D-1). No improvements to the existing access or additional access routes to the inlet channel and intake structure are recommended at this time.
